Hazardous Off-Gassing of Carbon Monoxide and Oxygen Depletion during Ocean Transportation of Wood Pellets

URBAN SVEDBERG^{1*}, JERKER SAMUELSSON² and STAFFAN MELIN³

Received 12 December 2007; in final form 22 February 2008

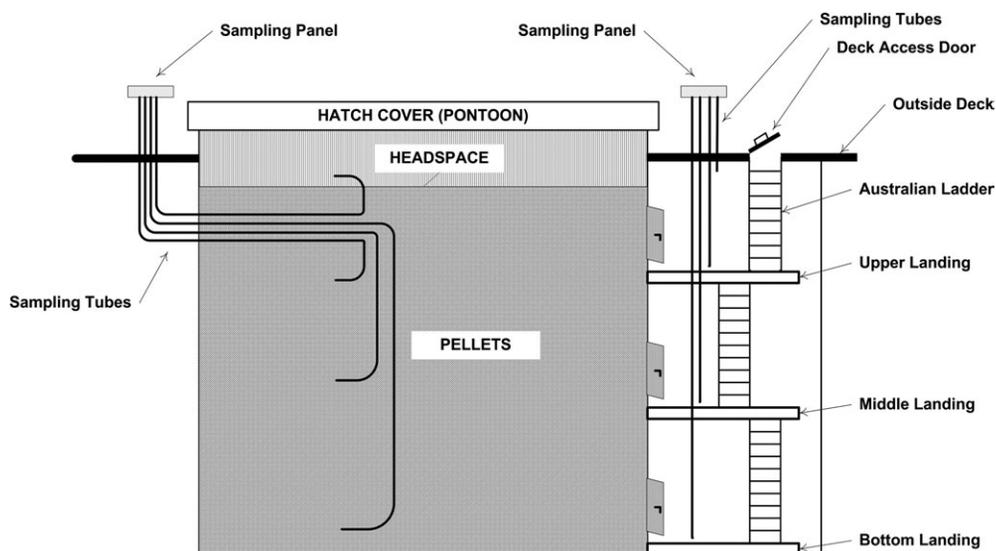
A typical vessel of this type has up to 10 cargo holds, each of which can hold ~ 3000 tons of wood pellets. Adjacent to the each hold is an access stairway (Australian ladder type) leading from the outside deck down to the bottom of the vessel, see Fig. 1. This ladder is entered through a deck-access door. The stairway has three landings, each equipped with a door in to the cargo hold. These doors are closed and sometimes taped during the voyage. Wood pel-

Fig. 1. Schematics of sampling points in the cargo hold and stairway on Vessel #4.

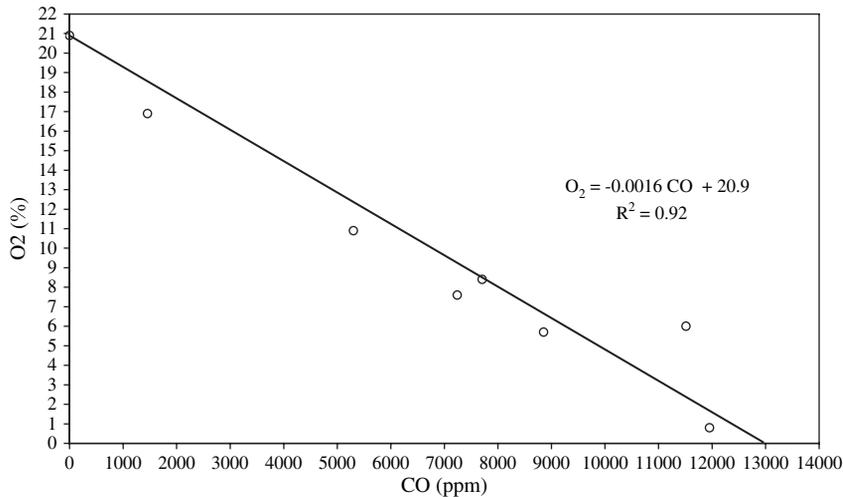
summarized in Table 1. Particularly notable are the high CO and CO₂ concentrations and the low oxygen levels. No indication of the presence of H₂S was seen. When the oxygen level from each vessel was plotted as function of the CO level, a high degree of correlation was obtained ($r^2 = 0.92$, see Fig. 2). Good correlation was also found between CO and butane equivalents ($r^2 = 0.93$) and CO₂ and propylene ($r^2 = 0.98$).

Fig. 2. The correlation between oxygen and CO concentrations in hatches and stairways. The point representing 20.9% oxygen and 0% CO is added manually.

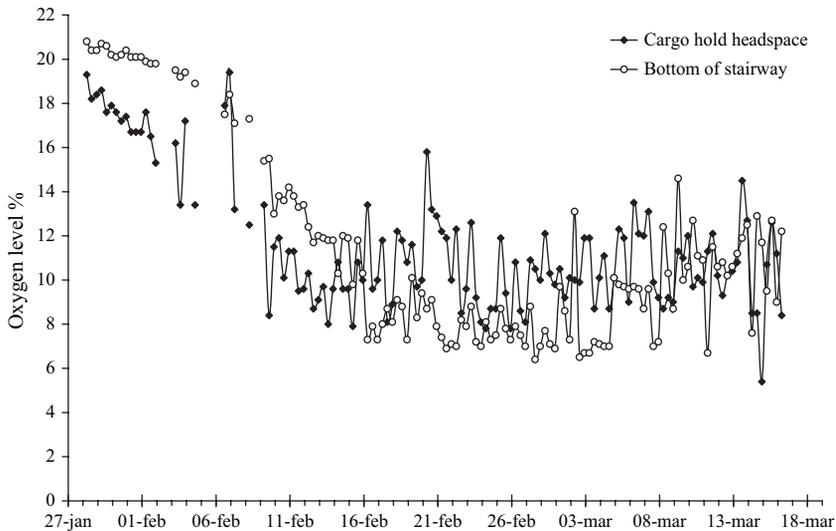
The results from the measurements aboard the vessels of oxygen at the bottom of the stairway and in the headspace of the cargo hold on Vessel #4 are described in Fig. 3. A steady state with ~10% oxygen level was reached after ~3 weeks at sea. The CO level in the headspace of the hold reached 900 ppm after 7 days. The onboard CO instrumentation was found to be unreliable over 1000 ppm and further evaluation of this parameter was not possible until the FTIR analysis was available at the time the cargo was discharged in the Port of Helsingborg.

Fig. 3. The oxygen level in cargo hold headspace and bottom of stairway measured during ocean voyage (Vessel #4).
