## Incident Description

During routine testing of the high-speed abort gates in June, two similar incidents occurred where the devices failed to operate.

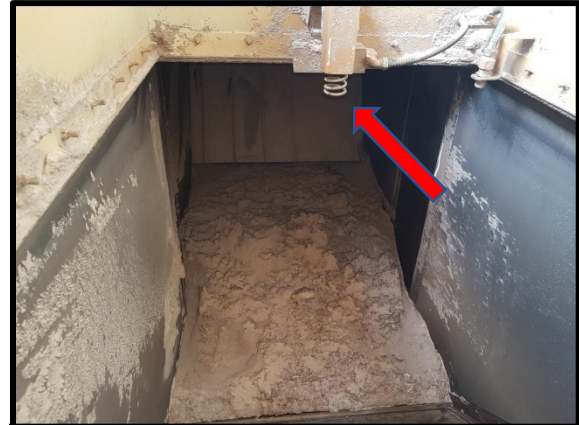
Inside of abort gate showing material build-up and activating spring assist

- Historically the abort gate testing has been completed with the main blower fans off
- During testing in June, the abort gate was tested with the fan in operation and the gate would not drop against the force of the fan
- The gate, sensor and upstream/downstream equipment was fully inspected with no issues detected
- The build-up of material between the abort gate and back blast damper was cleaned
- The magnet was releasing properly and springs were adjusted to the maximum tension with additional wedges added to increase the force. Despite the changes, the gate would still not drop against the force of the fan
- The contractor added 'pre-loaded helper springs' which finally permitted the gate to drop against the force of the fan
