# Oxygen Depletion and Formation of Toxic Gases following Sea Transportation of Logs and Wood Chips

URBAN SVEDBERG<sup>1\*</sup>, CAROLINE PETRINI<sup>2</sup> and GUNNAR JOHANSON<sup>3</sup>

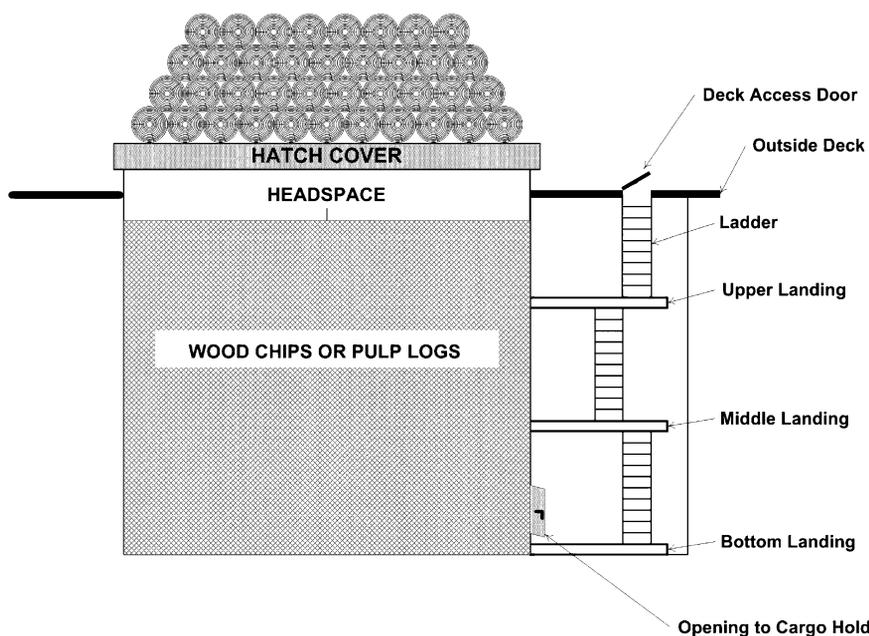
**Fig. 1.** Schematic drawing of a typical hold and its connecting stairway. The cargo on top of the hatch cover is symbolized by logs. The opening into the hold at the lower landing is symbolized by a door. This opening was sometimes covered with boards to prevent the cargo from falling into the stairway.

The information about each cargo was collected from the ship's crew at the time of sampling. The estimated time from completion of loading to discharge was 37–66 (mean 46) h. The types of wood carried were pine, spruce, birch, and aspen. The storage time on land for logs varied from recent harvesting to several years. In a few cases, the logs had been stored in water. The vessels were bulk carriers with one or two cargo holds. Wood chips were always transported inside the holds while logs were transported either in the holds or as deck cargo on top of the hatch covers, as illustrated in Fig. 1. A stairway led to each individual hold with an opening into the hold located at the lowest landing. The access doors to the stairways were normally reached from the outer deck. However, in a few ships, a separate storage or utility room had to be entered to reach the access door to the stairway. The access doors were closed throughout the voyages.

Measurement of toxic gases was carried out using a direct-reading handheld multi-gas monitor. In addition, air samples were collected in Tedlar® bags for later analysis in the laboratory by FTIR. The samples were collected from the undisturbed air in the stairways before removal of the hatch covers. The access door was temporarily opened and a sampling tube was lowered as far as possible, typically between 4 and 8 m depending on the design of the stairway. The access door was left ajar allowing enough space for the sampling tube. In total, 76 individual staircases were sampled in the 41 shipments investigated. One of the participating ships assisted by doing their own sampling, and 22 of the 41 shipments were sampled with a handheld monitor by a crew member on

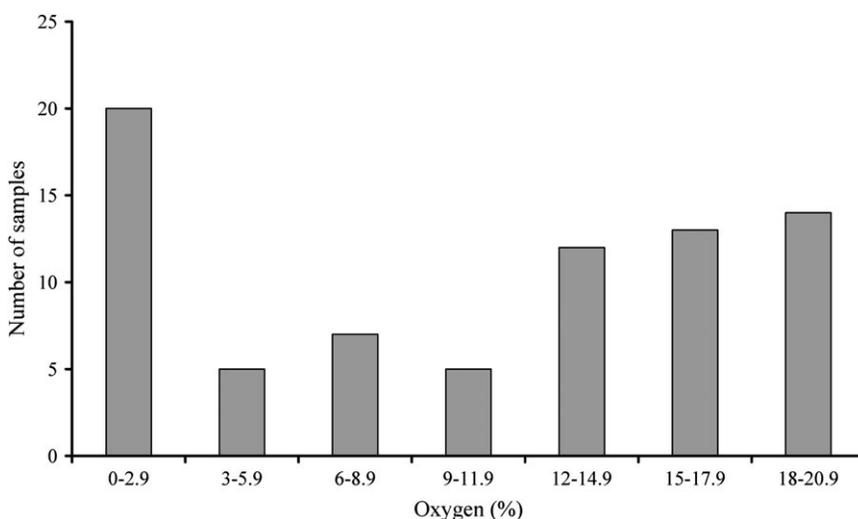
Fig. 2. Frequency distribution of oxygen levels measured with a handheld gas monitor in the 76 stairways.

Varying degrees of oxygen reduction and  $\text{CO}_2$  elevation were seen in the stairway air samples from the ships. The mean oxygen level was  $10 \pm 7.3\%$  (mean  $\pm$  standard deviation,  $n = 76$ ). The levels ranged from normal ambient air concentration of 20.9% to complete depletion. In nearly one-fifth of the samples, the oxygen level was 0% and in one-third it was  $<6\%$  (Fig. 2). Notably, complete depletion was observed even in samples taken as early as  $\sim 37$  h after loading, although no correlation between estimated transport time and oxygen level was seen. As anticipated, a seasonal variation in oxygen depletion was seen. During the cold season, the depletion was less pronounced and no zero readings were recorded (Fig. 3). Unsafe conditions with oxygen levels  $<6\%$  were seen to develop with both softwood and hardwood.

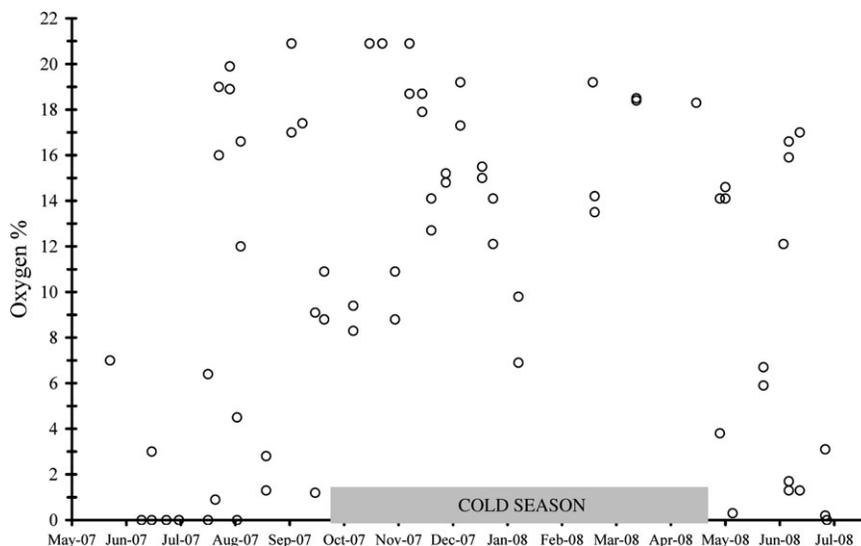
**Fig. 3.** Temporal distribution of oxygen levels measured with a handheld gas monitor in the 76 stairways. Each dot represents the oxygen level in an individual stairway. One or two stairways were sampled in each ship. The shaded area indicates the cold season when less oxygen depletion was seen.

The seasonal variation in oxygen depletion (Fig. 3) suggests that the microbiological activity is temperature dependent. Nevertheless, one fatal accident during unloading of logs took place in the cold month of

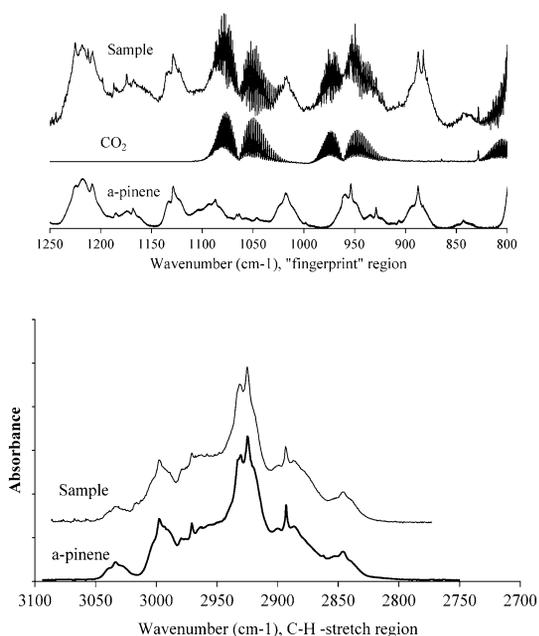
**Fig. 4.** FTIR spectrum of a representative air sample from a stairway. The fingerprint region and the C-H stretch region (the collective peak of all C-H bonds in hydrocarbons) are depicted. The spectral features in the sample are well described by the combined library spectra of  $\alpha$ -pinene and  $\text{CO}_2$ .

The FTIR analysis revealed that  $>90\%$  of the hydrocarbons were explained by monoterpenes, mainly  $\alpha$ -pinene, as determined by peak area comparison of the C-H stretch region of  $2800\text{--}3050\text{ cm}^{-1}$  and the ‘fingerprint’ region of  $750\text{--}1250\text{ cm}^{-1}$  in the spectrum (Fig. 4). The mean hydrocarbon concentration expressed as  $\alpha$ -pinene equivalents was  $41 \pm 51$  ppm ( $n = 26$ ). Ethylene was occasionally detected in the 10-ppm range. Hydrocarbons may constitute a risk

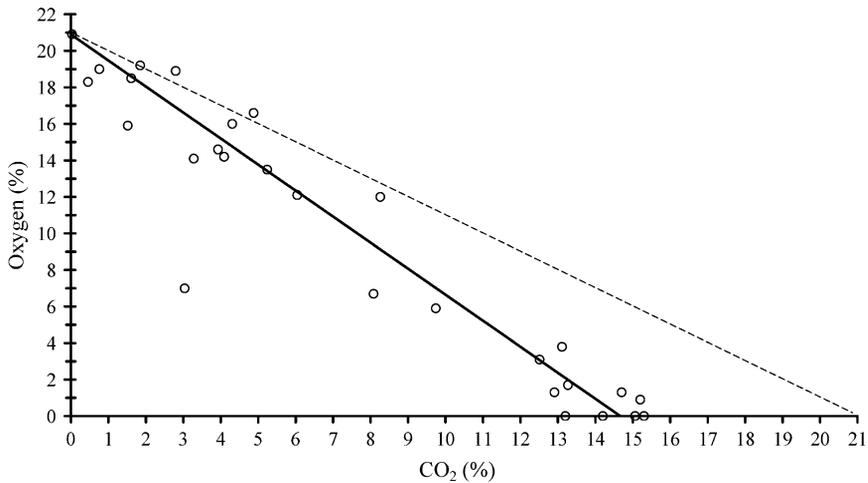
**Fig. 5.** Relation between simultaneously measured oxygen and CO<sub>2</sub> levels in 26 stairway air samples. The slope of the regression line of  $-1.425$  (forced through the normal ambient atmospheric conditions of 20.9% O<sub>2</sub> and 0.035% CO<sub>2</sub> at the y-intercept) suggests that the CO<sub>2</sub> released in to the air corresponds to close to 70% of the oxygen depletion. The dashed line describes the stoichiometric relation of 1 between oxygen depletion and CO<sub>2</sub> formation.

A highly statistically significant correlation was obtained ( $r = -0.95$ ,  $P < 0.001$ ,  $n = 26$ ) between oxygen and  $\text{CO}_2$ , (Fig. 5). The slope of the regression line of  $-1.45$  suggests that  $\sim 70\%$  of the oxygen loss is recovered as  $\text{CO}_2$  in the gas phase. A statistically significant correlation was also seen between oxygen and  $\alpha$ -pinene ( $r = -0.57$ ,  $P < 0.01$ ,  $n = 26$ ) and between  $\text{CO}_2$  and  $\alpha$ -pinene ( $r = 0.61$ ,  $P < 0.001$ ,  $n = 26$ ).

The disappearance of oxygen from the atmosphere in the cargo holds could be the result of, but not limited to, two plausible mechanisms: (a) bioconversion of oxygen to CO<sub>2</sub> by microorganisms and (b) oxidation of wood constituents. Based on the relation between oxygen and CO<sub>2</sub> levels (Fig. 5), we estimate that  $\sim 70\%$  of the oxygen consumed is recovered as CO<sub>2</sub> in the gas phase. The high concentration and rapid formation of CO<sub>2</sub> is a strong indication of extensive microbiological activity in cargoes of logs and wood chips. This contrasts with our previous finding in measurements of wood pellet storages, where slower auto-oxidative degradation processes producing CO predominate (Svedberg *et al.*, 2004). The difference in microbiological activity is further supported by the high number of microorganisms present in wood chip and bark samples, and the absence of microorganisms in wood pellets (Table 1). Similar results have been reported by Madsen *et al.* (2004), who found high bacterial activities in dusts from straw and wood chips ( $8 \times 10^4$  and  $3.1 \times 10^6$  cfu mg<sup>-1</sup>, respectively) and low activities in dusts from briquettes and wood pellets (20 and 60 cfu mg<sup>-1</sup>, respectively). A plausible explanation for the differences in microbiological activity is that wood chips and logs are fresh wood products with a water content of up to 50%, whereas wood pellets are dried at up to 500°C in the production process so as to have a water content  $< 8\%$ . Both the high temperature and the low water content create very unfavorable conditions for microbiological activity in the pellets.

The 70% recovery of consumed oxygen as CO<sub>2</sub> in the air is intriguing as one might expect almost complete recovery. One explanation may be the different solubility of CO<sub>2</sub> and oxygen, the former being almost 30 times more soluble in water (Windholz, 1983). Thus, whereas the oxygen is consumed directly from the air, some of the CO<sub>2</sub> formed is retained as carbonic acid (H<sub>2</sub>CO<sub>3</sub>) in the water within the wood material or the hold itself. The equilibrium between CO<sub>2</sub> and H<sub>2</sub>CO<sub>3</sub> and, hence, the solubility of CO<sub>2</sub> is temperature dependent. The variability around the regression line in Fig. 5 may partly be explained by differences in water content and temperature between the shipments.

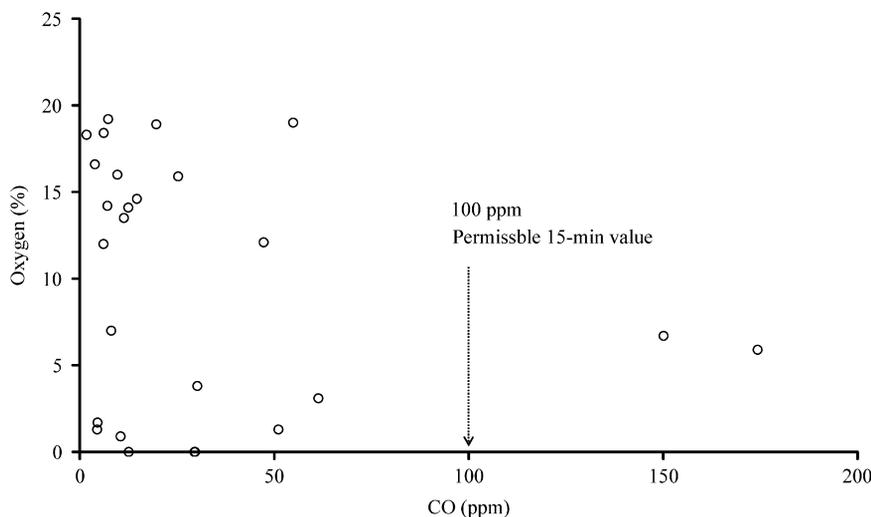
**Fig. 6.** Relation between oxygen and CO levels in simultaneously collected stairway air samples (CO measured by FTIR). The vertical arrow at 100 ppm indicates the Swedish occupational short-term value for CO (SWEA, 2005).

Swedish STEL of 100 ppm (SWEA, 2005), except in two samples where the oxygen level is ~6% (Fig. 6). Hence, disregarding the single sample discussed above, oxygen levels >20% seem safe also with regards to CO<sub>2</sub> and CO. Notably, this applies only to short stays in confined spaces containing wood chips and logs. The conditions may be very different for other organic materials such as wood pellets.
